**WALL
 CUTOUT
 TEMPLATE**
 for
CablePassThru

Preliminary Report: ASC Cable Pass Thru measures at least STC 48

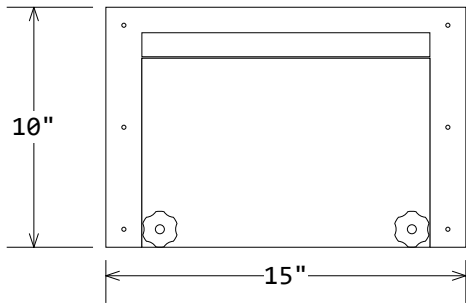
**FACE VIEW,
CLOSED**

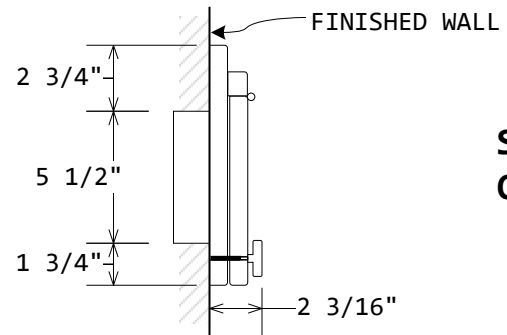
**SIDE VIEW,
CLOSED**

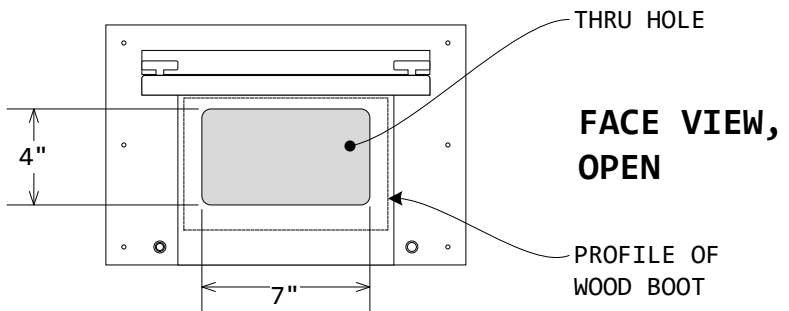
**FACE VIEW,
OPEN**

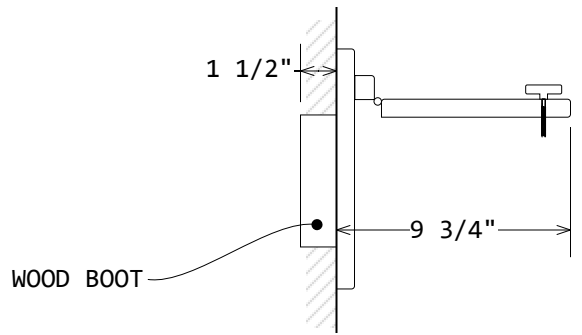
**SIDE VIEW,
OPEN**

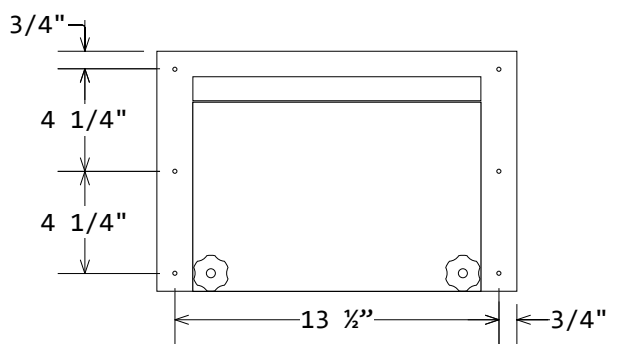
**MOUNTING
HOLE
LOCATIONS**

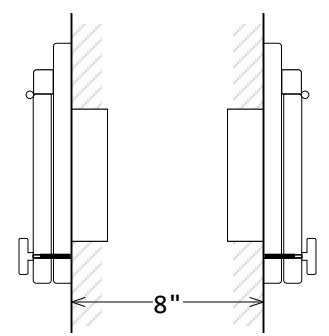
**MAXIMUM
WALL
THICKNESS**
(standard neoprene tunnel)

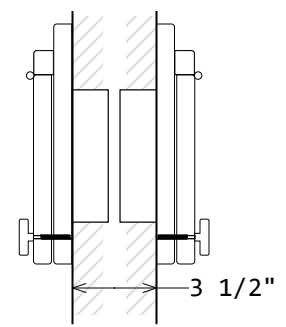
**MINIMUM
WALL
THICKNESS**

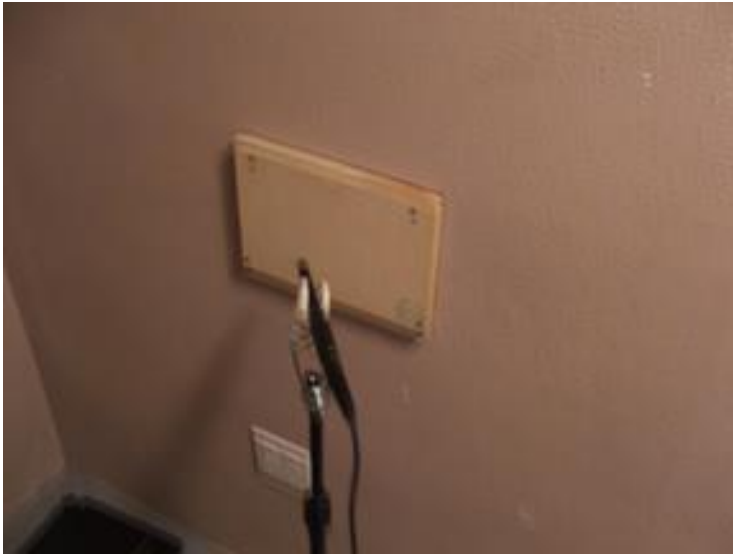
OUTSIDE TESTING ROOM
BASELINE: 3/4" PLYWOOD

A hole was cut through the inner and outer walls of our test lab, 6" by 9" wide, sized to install a standard ASC Cable Pass Thru. As a reference, a square of 3/4" plywood overlaid the holes and screwed down. It registered at least STC 47. Then the standard Cable Pass Thru set was installed, with four 1/4" microphone cables running through both doors. It measured at least STC 47.5. We tested each door of the Cable Pass Thru. With the noise-side door closed, quiet-side opened, we measured STC 39 and with the noise-side open and quiet-side closed we measure STC 44.

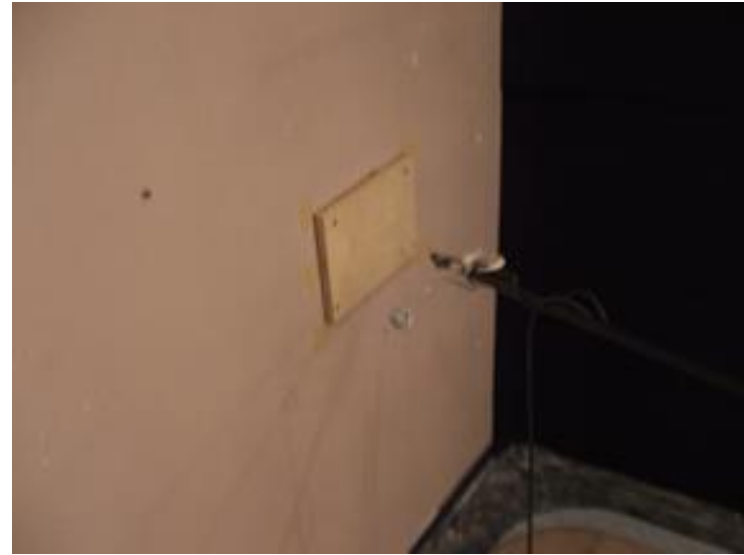
INSIDE TESTING ROOM
BASELINE: 3/4" PLYWOOD

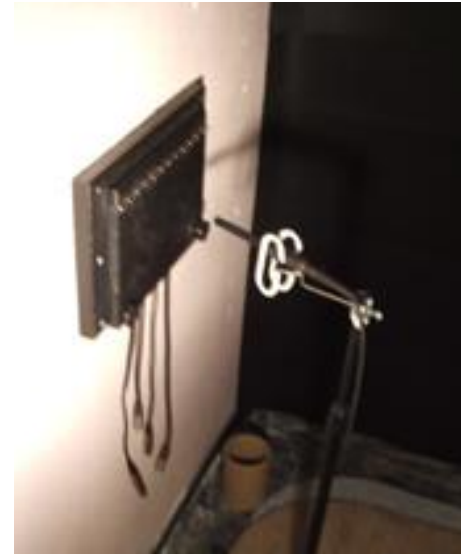
INSIDE TESTING ROOM
TEST SPECIMEN: CPTC-1.0
