Beyond the Thunder Dome

The Acoustical Rescue of a Venue from Hell

by Daniel Sweeney

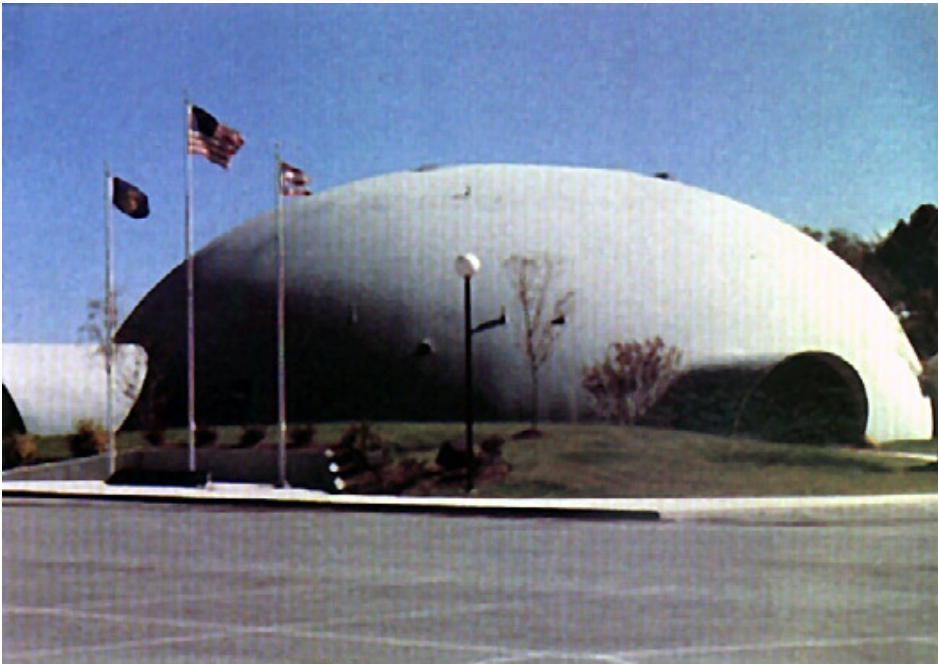
The basic structure of the New Bremen Legion Hall is a concrete dome. The dome consists of a four inch thick shell of concrete which was literally sprayed over a huge inflated plastic form. The dome is not circular; rather it resembles one half

of an egg shell. The structure measures 120 feet in length, and is 100 feet at its widest point. Maximum height is 35 feet. An interior concrete block wall divides the structure at the point of greatest height. The smaller segment of the dome is used as a club house, while the larger segment was designated a concert/dance space.

The New Bremen Legion Hall in Ohio.

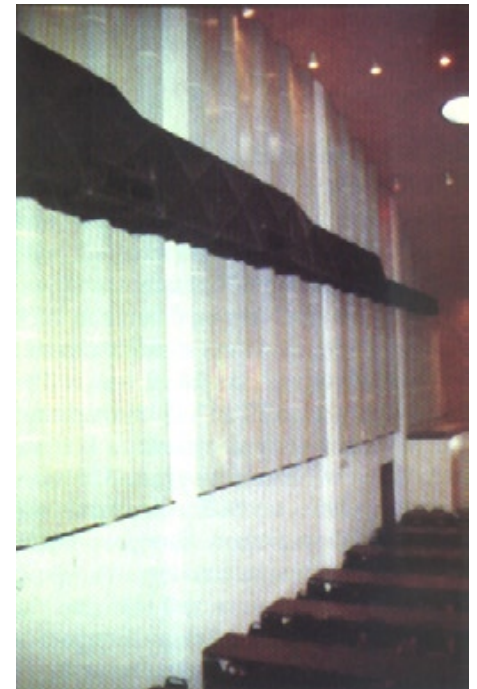
ASC TubeTraps in use at the hall.

For bass absorption Noxon settled on a modification of an existing product, the company’s 16” Half Round. This is essentially a fabric covered half cylinder designed to lie flush against side walls. For this application Noxon left the fabric off on the flat side to reduce costs, and specified that the half cylinders be directly bonded to the tectum on the partition wall. The Half Rounds were stacked one on top of the other from a few feet above floor level all the way to the ceiling, and a total distance of two and a half feet separated each vertical stack. In this space sheets of corrugated fiberglass were placed, again glued directly to the tectum. The fiberglass sheets, which are basically a ceiling material, had flat-topped corrugations which made for a good glue bond, and which also

In total, 410 running feet of Traps were employed in the job. Total cost of the material supplied by ASC was \$9,000. The total bill presented to the American Legion by Panacom was roughly \$15,000. No sound reinforcement equipment was provided.

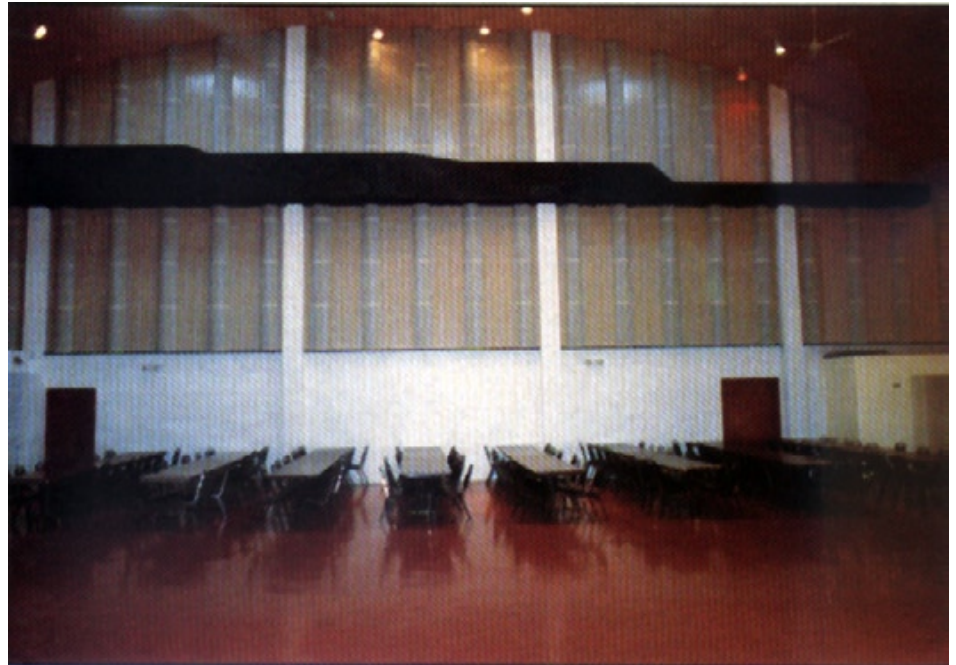
“The RT60 for 63 Hz was down to 2.92 seconds and an octave up the time was 2.64 seconds. Measurements were not made for frequencies past 500 Hz, but the hall was subjectively much livelier.”

After the “fix,” improvement in RT60 was dramatic.

The New Bremen hall was subsequently re-measured by John Murray with Techron equipment, and improvement in RT60 terms was dramatic. The RT60 for 63 Hz was down to 2.92 seconds and an octave up the time was 2.64 seconds. Measurements were not made for frequencies past 500 Hz, but the hall was subjectively much livelier. In fact subjective impressions of hall acoustics were uniformly positive after Panacom had finished its work, and the Legion began to book acts and stage events on a profitable basis.
